Counties Manukau District Health Board  
Private Bag 93323  
Auckland 1640  
New Zealand

10 May 2019

### **Franklin Memorial Hospital - Intrusive Investigation Summary**

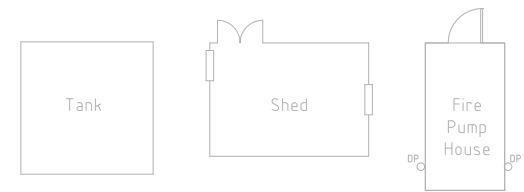
Section No.: Exterior Wall 1

Description/Comments: Exterior wall on southern side of building. Removed the ventilation net to observe cavity construction. Bricks with minor cracks.
